## Structural Assessments for Commercial Property Agents

Author: Ronald Gultom, Civil Engineering Leader/Analyst Auckland, CSI.

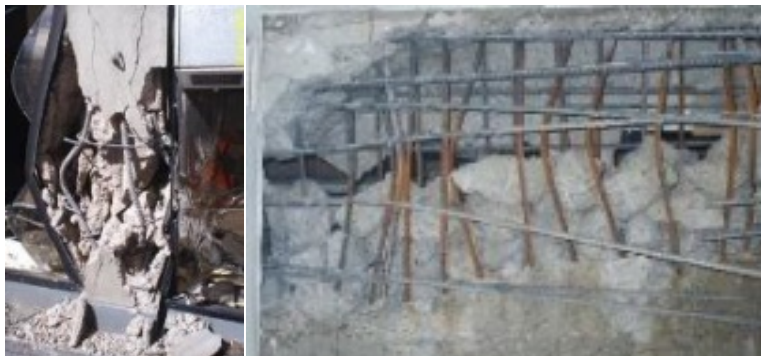
*Figure 2 Failure due to inadequate transverse reinforcement and confinement (NZSEE et al., n.d.-a)*

- Inadequate splice (overlap) development length, in beam, column or wall, resulting in concrete crushing/crumbling around the splicing region and potential weak-column/strong-beam mechanism (Figure 1)
- Inadequate shear reinforcement and confinement in column and wall elements especially those with high axial load. This is mostly due to too large of transverse reinforcement spacing in critical regions and results in axial-shear failure and buckling of longitudinal reinforcement (Figure 2)
- Different type of beam longitudinal reinforcement anchorage into the beam-column joint, which lead to different expected performance and failure mechanism (Figure 3)
- Inadequate longitudinal reinforcement ratio in walls, which results in large, single crack in the plastic hinge region and potential tensile rupture of longitudinal reinforcement, which can lead to sudden collapse.

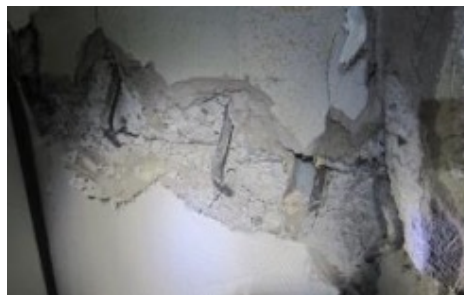
Figure 4 Single crack opening of wall with low long. reinforcement ratio (NZSEE et al., n.d.-a)

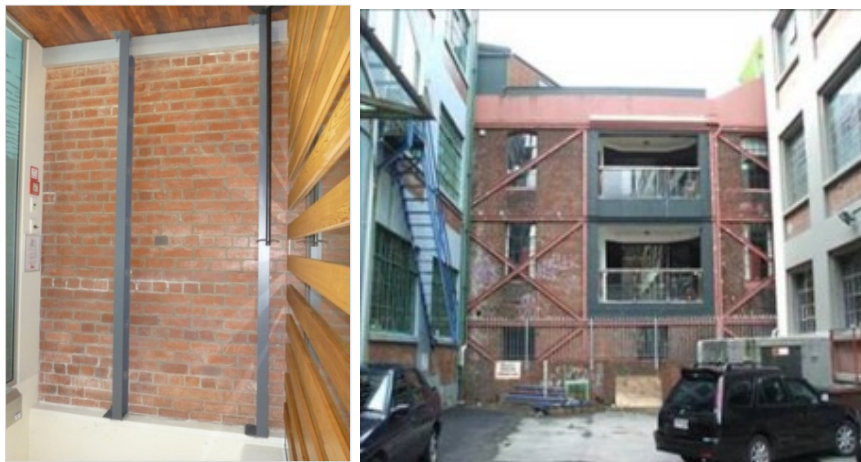
Figure 7 Anchoring steel posts or frames to increase in-plane and out-of-plane flexural capacity (NZSEE et al., n.d.-c)

Due to the standards and construction practices around at the time of their constructions, strengthening of URM buildings has become an urgent attention to TA across New Zealand. A lot of the strengthening methods involve attaching structural steel to the masonry structural elements to increase capacity or improve connections between structural elements. For example, wall-to-diaphragm connection using anchor plate (steel angle, Figure 6) or improving out-of-plane and in-plane stiffness with steel posts or steel frames
